POWER OUTAGE UPDATE –

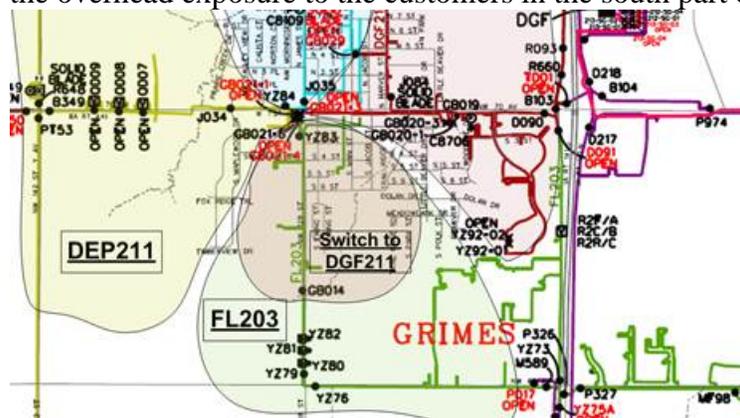
On January 13th, crews started performing a pole-by-pole inspection of the mainline circuit for FL203 to tighten hardware. Additionally, engineering personnel started performing a pole-by-pole infrared inspection of the mainline circuit for FL203 to identify equipment issues and loose connections. Repairs were completed during the inspection, with any equipment replacements completed. Following this activity, the switching of customers on the south side of Grimes from circuit FL203 to circuit DGF211 was completed last night. Below is the map showing how this reduces the overhead exposure to the customers in the south part of Grimes.
